**Pool Inspection Report - 14252 Hunters Ridge Dr West Glen St  
Mary FL 32040**

**Pool Details**

Date:	16 Jun 2020
Pool Location:	14252 Hunters Ridge Drive West Glen St Mary FL 32040
Latitude/Longitude:	30.336849801271, -82.179190311657
Inspection Requested by:	Terry & Sarah Constable
Pool Inspected by:	Tim Barnhart Sr

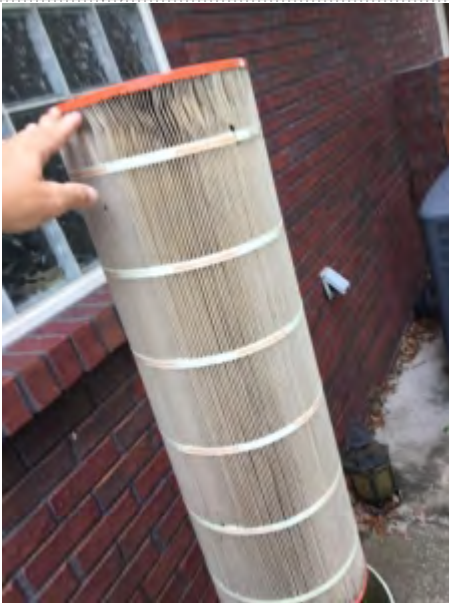
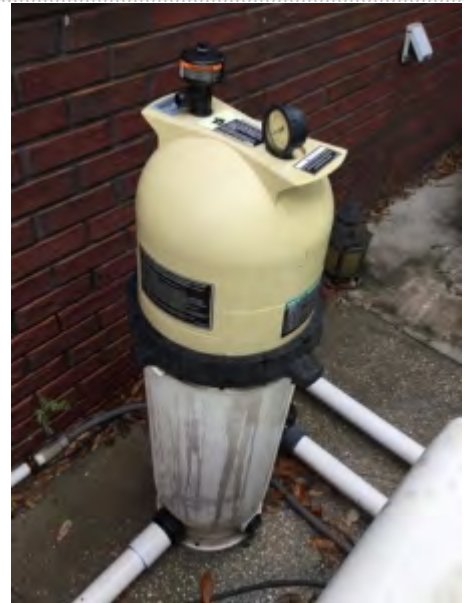
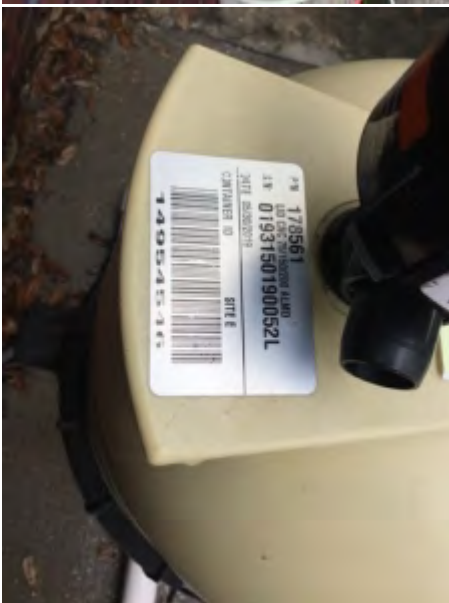
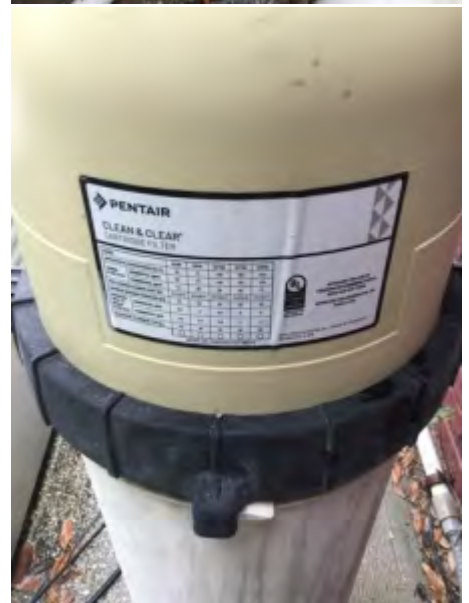
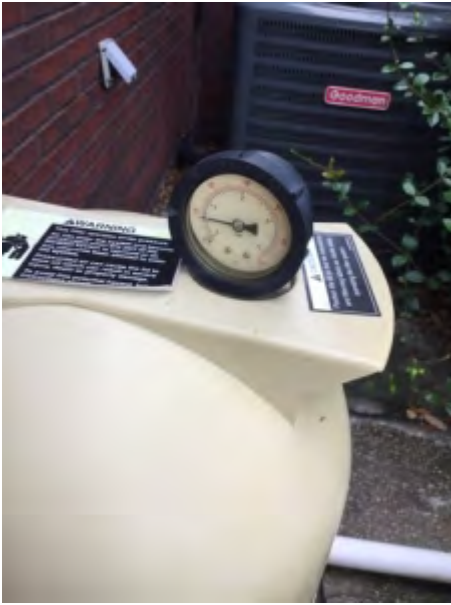
# Filter

Pool:	Pool/ Spa
Type:	Cartridge filter
Make/Model	Pentair Clean & Clear 200
Functional:	Yes
Notes:	Filter is in fair condition. Filter lid is 1 year old. Cartridge is dirty will need cleaned.
Suggested Repairs	I would recommend replacing the cartridge - \$150

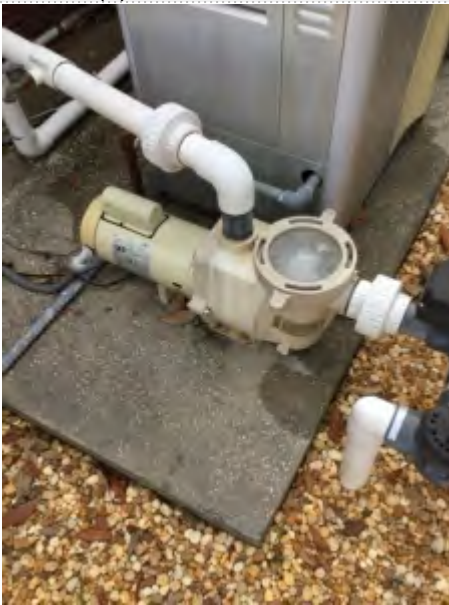
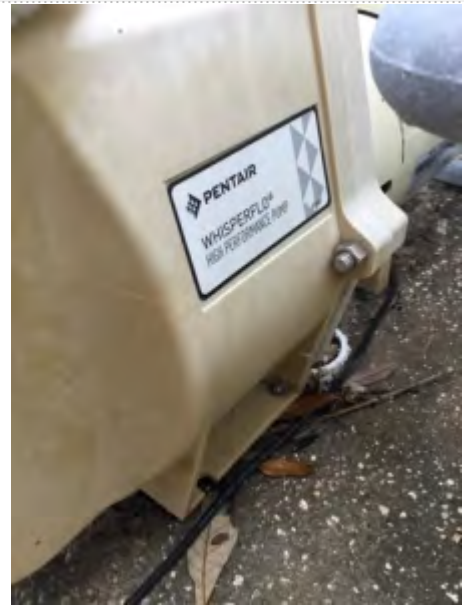
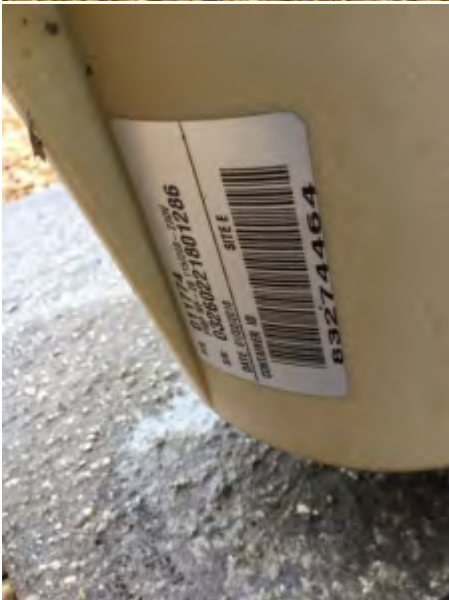
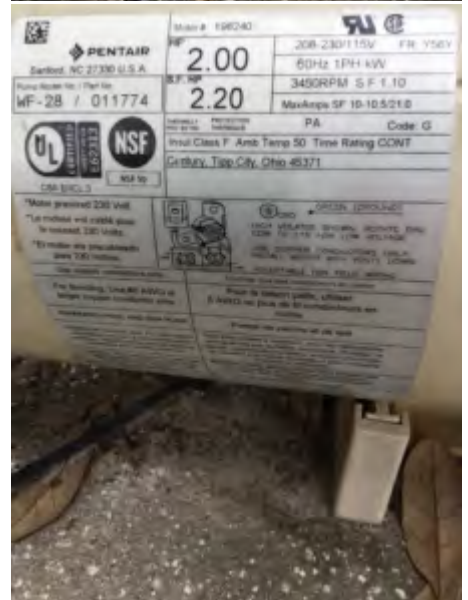
# Filter Circulation Pump

Pool:	Pool/Spa
Type:	Single speed
Make/Model	Pentair Whisper Flo 2 hp
Functional:	Yes
Notes:	Pump is in good condition . Pump is 2 years old
Suggested Repairs	None

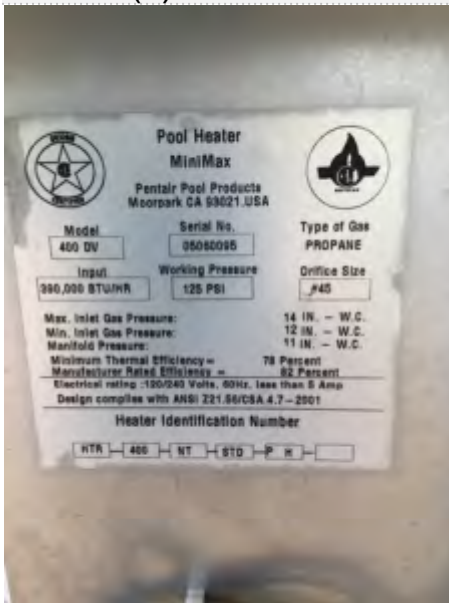
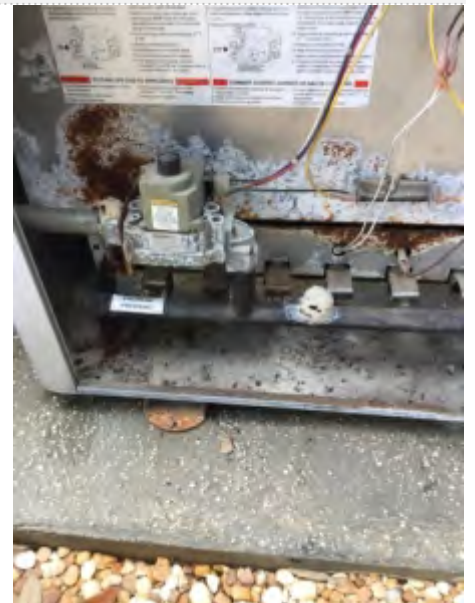
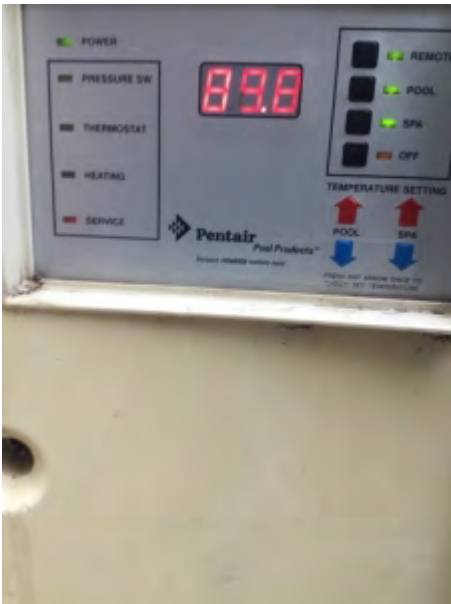
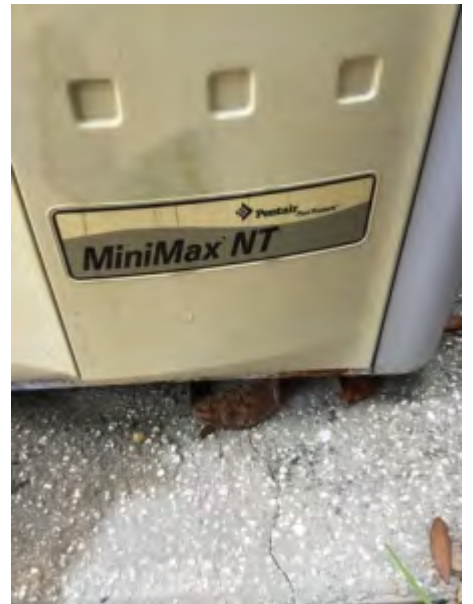
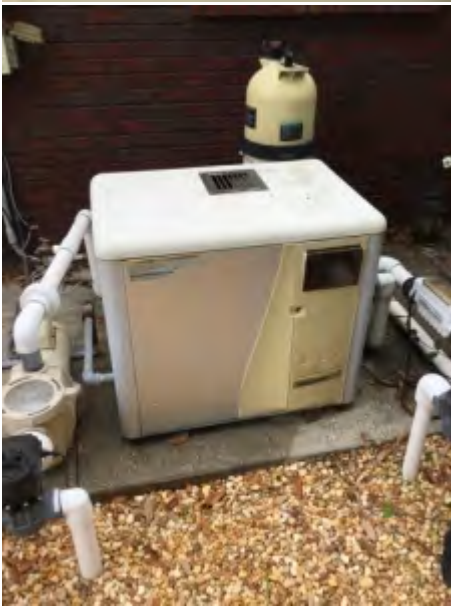
## Heater

Pool:	Pool/Spa
Type:	LP gas
Make/Model	Pentair Mini-Max NT
Functional:	No
Notes:	The service light is on and I can't get the heater to do anything . The pressure Switch light is also on. Due to age and condition heater unit will most likely need to be replaced.
Suggested Repairs	Schedule a certified technician to diagnose and repair - Chambers Heating / Certified Pentair Factory Rep

The Heater will need diagnosed by a certified technician and repaired/ Replaced.

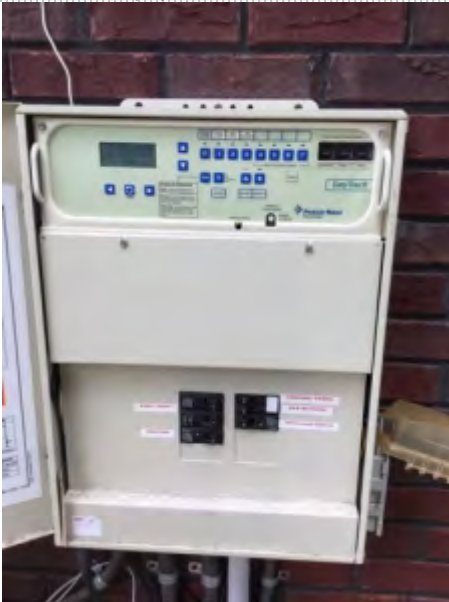
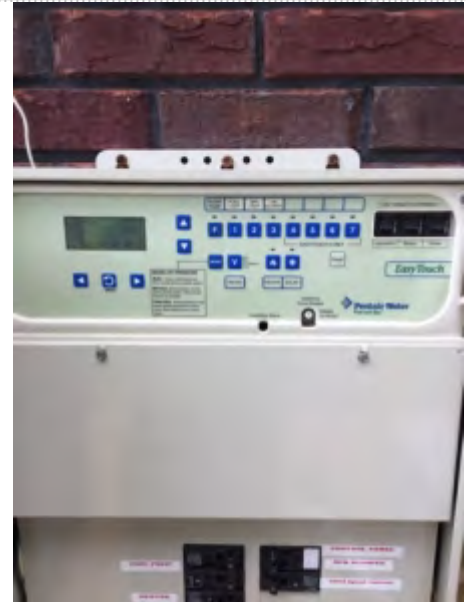
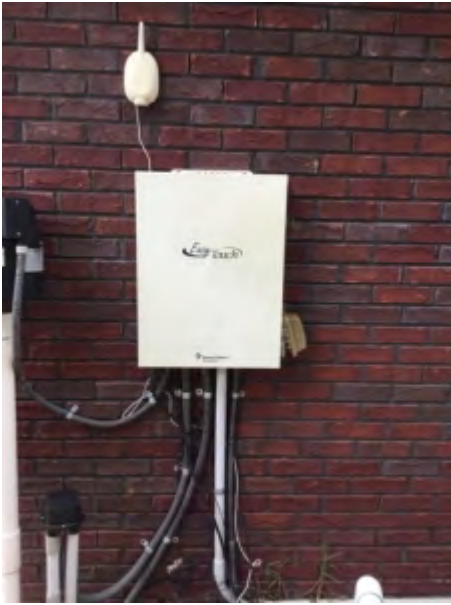
## Time Clock for Circulation Pump

Pool:	Pool/ Spa
Type:	Automation
Make/Model	Pentair Easy Touch
Functional:	Yes
Notes:	Pool automation is in good condition. Features operate when prompted through automation
Suggested Repairs	None

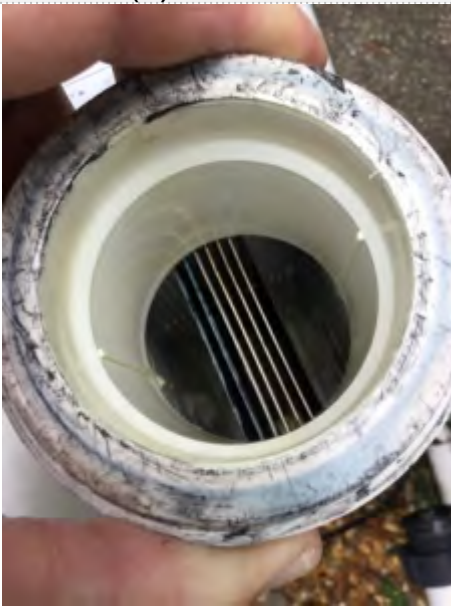
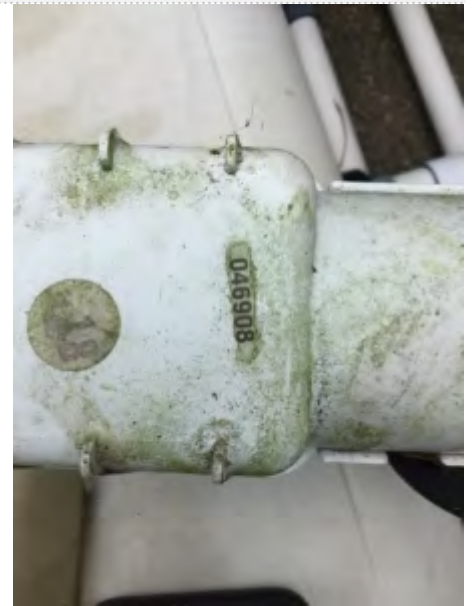
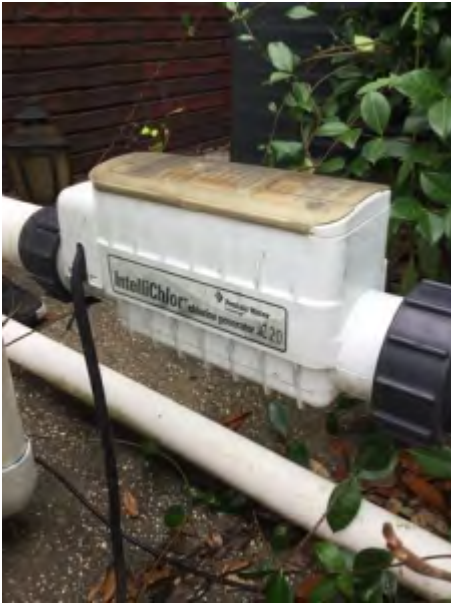
## Chlorine Generator

Pool:	Pool
Type:	Saltwater chlorine generating system
Make/Model	Pentair Intellichlor IC20
Functional:	Yes
Notes:	Cell is in fair condition. Salt level 3800 ppm/ Chlorine level 11 ppm. The cell is in need of cleaning it is operational but is nearing the end of its life expectancy.
Suggested Repairs	I would recommend replacing the cell with an IC30 cell - \$700

The salt cell is functioning but will need cleaning at least if not replaced.

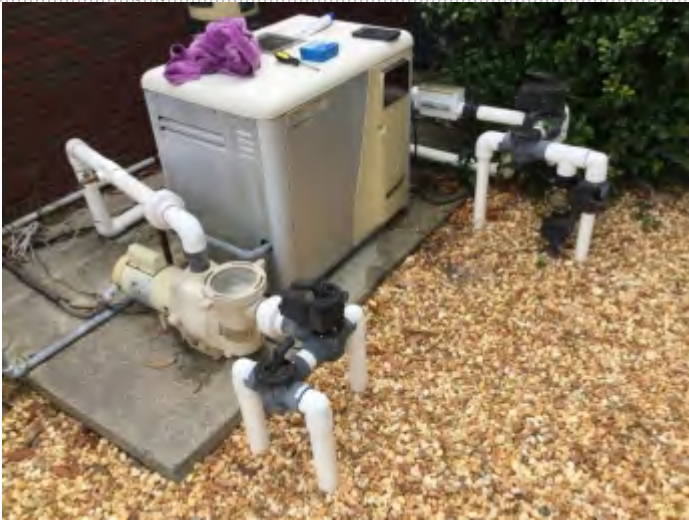
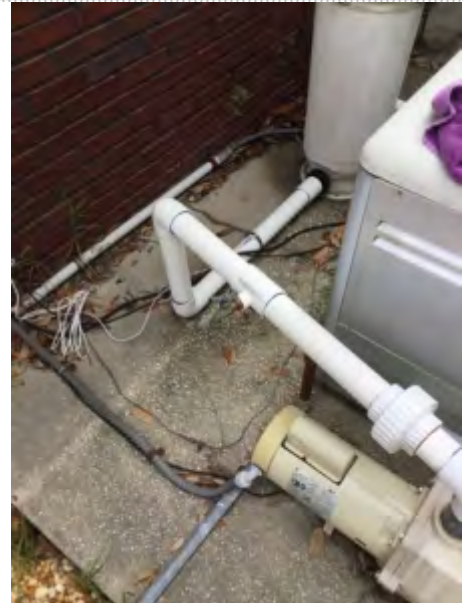
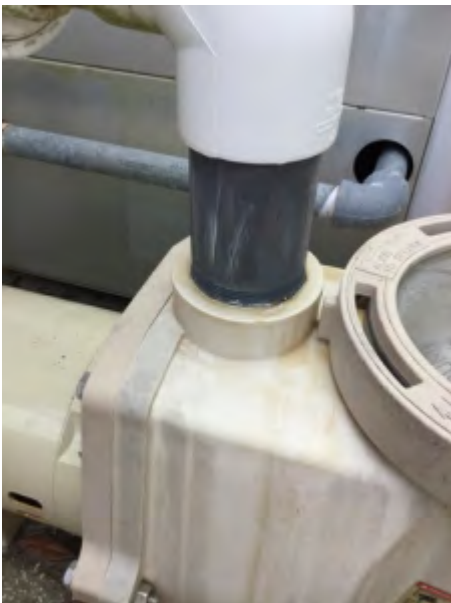
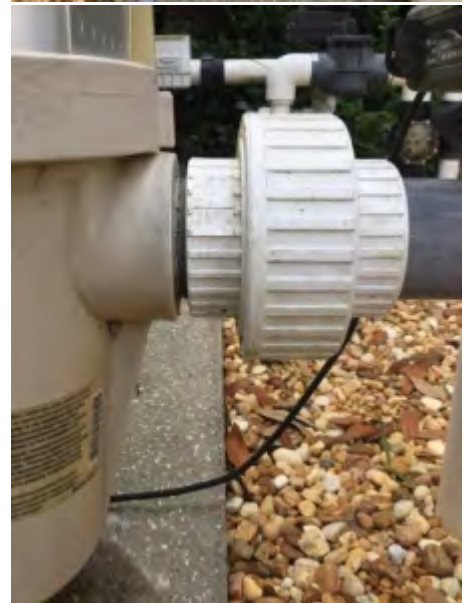
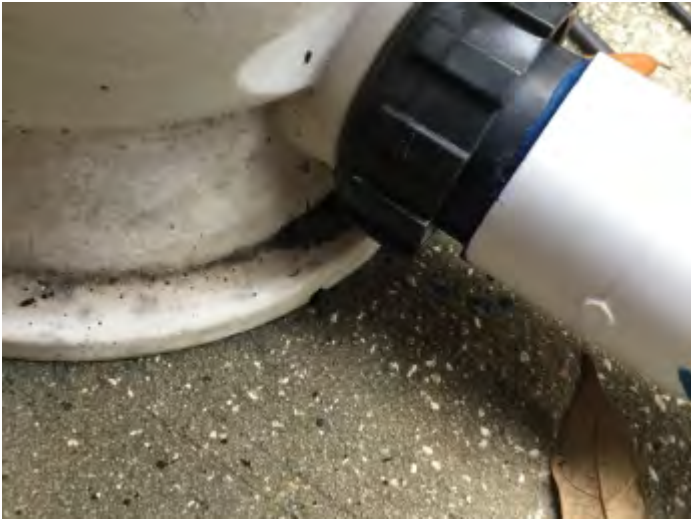
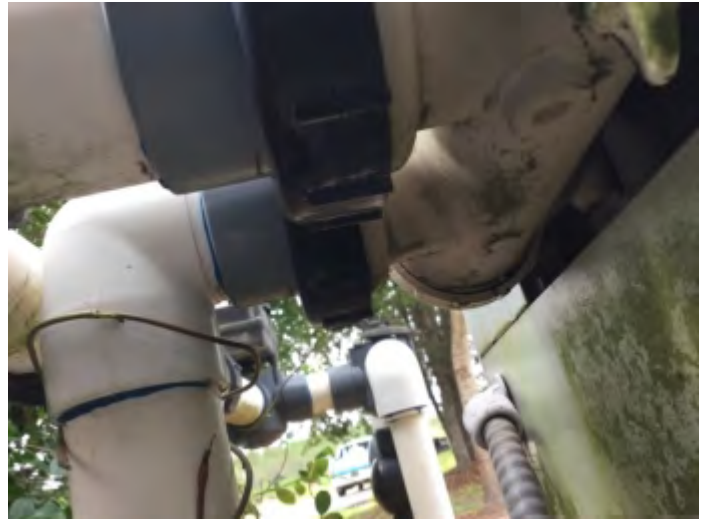
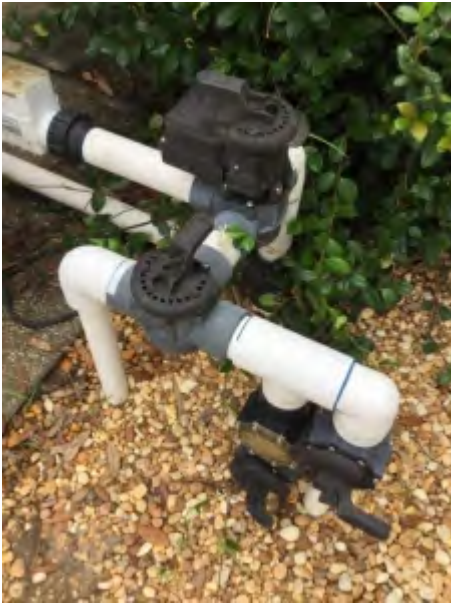
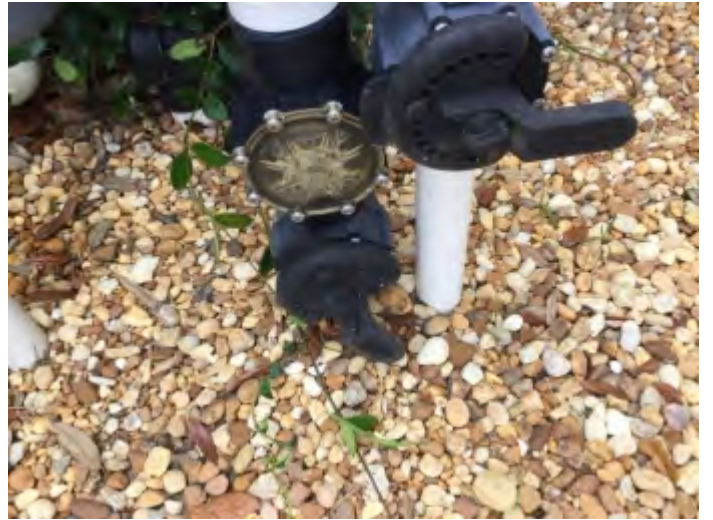
## Visible Plumbing System

Type/Style:	2" PVC
Condition:	Plumbing is in fair condition .
Notes:	There is no visible leaks in the above ground plumbing at the equipment . All three way valves are operational and actuators work when prompted
Suggested Repairs	None

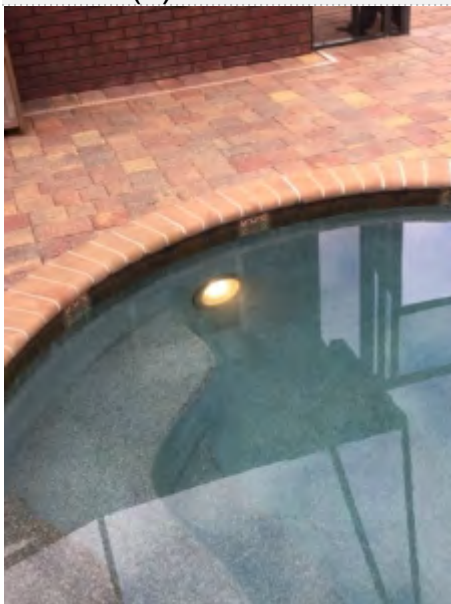
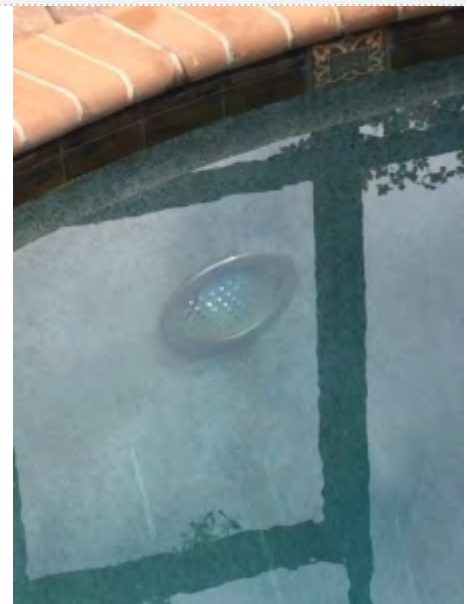
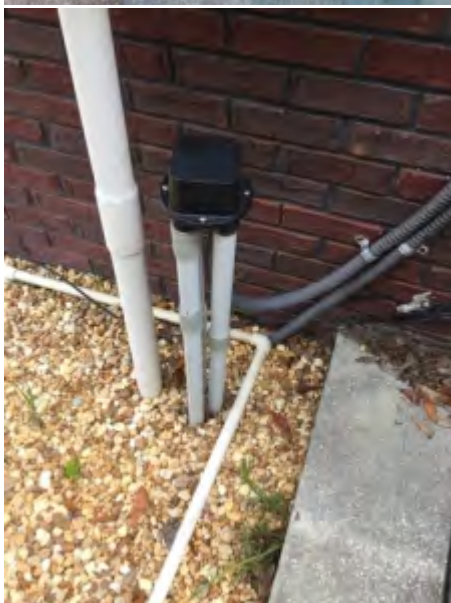
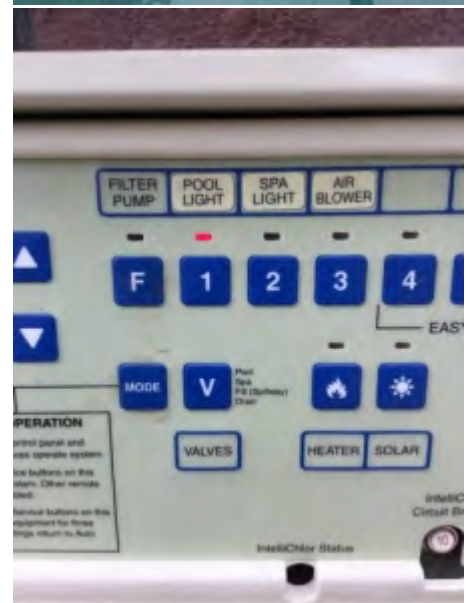
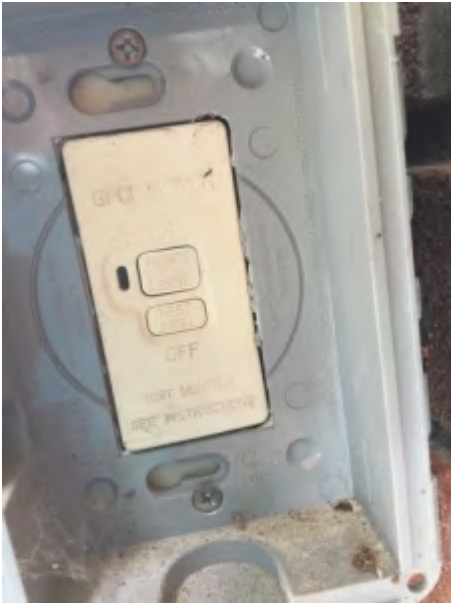
## Pool & Spa Light with Ground Fault Circuit Interrupter (GFCI):

Pool:	Pool
Type:	120V Incandescent Light x 2
Make/Model	Pentair Amerilite
Functional:	Yes
Notes:	There are 2 pool lights 1 works ( spa end ) 1 doesn't (far end) GFCI is operational
Suggested Repairs	Replace bulb and seal in the light at the far end of the pool - \$285

The deep end pool light will need a new bulb and seal to be functional.

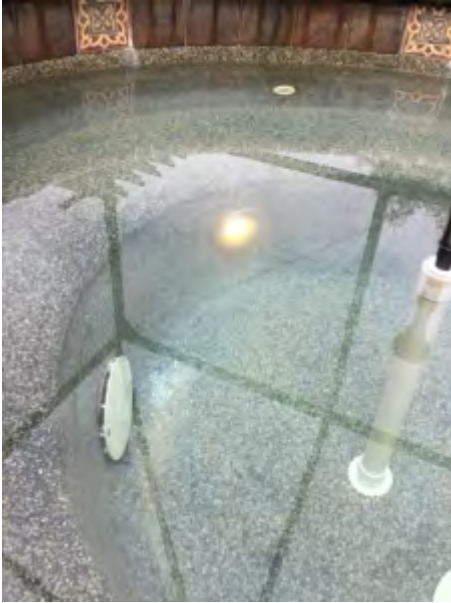
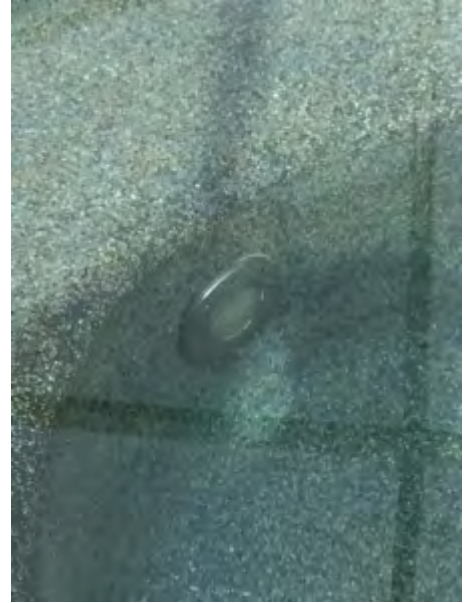
Pool:	Spa
Type:	120V incandescent light
Make/Model	Pentair Spa Brite
Functional:	Yes
Notes:	Light operates when prompted
Suggested Repairs	None

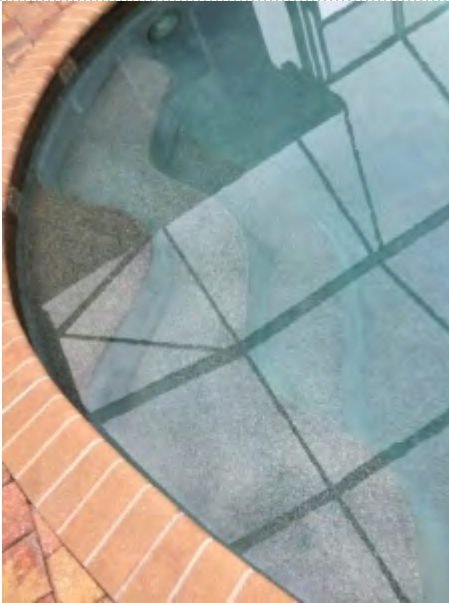
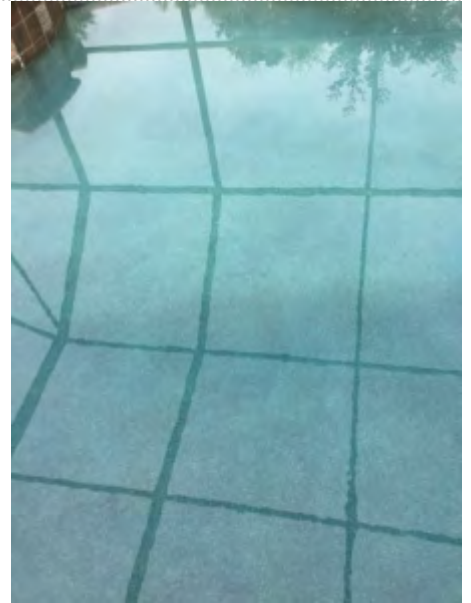
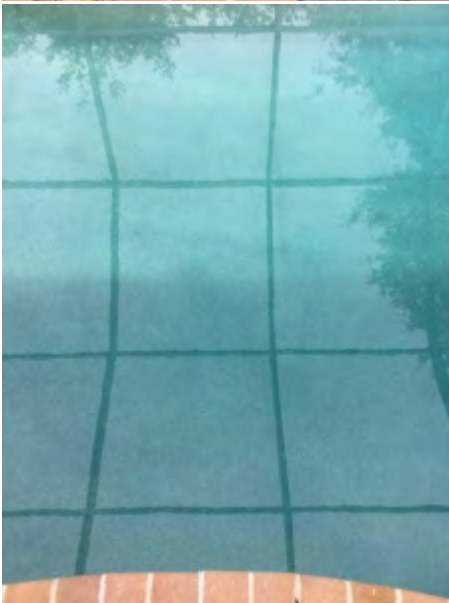
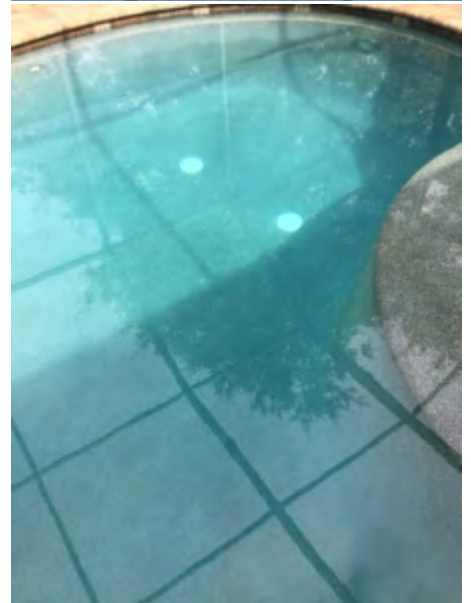
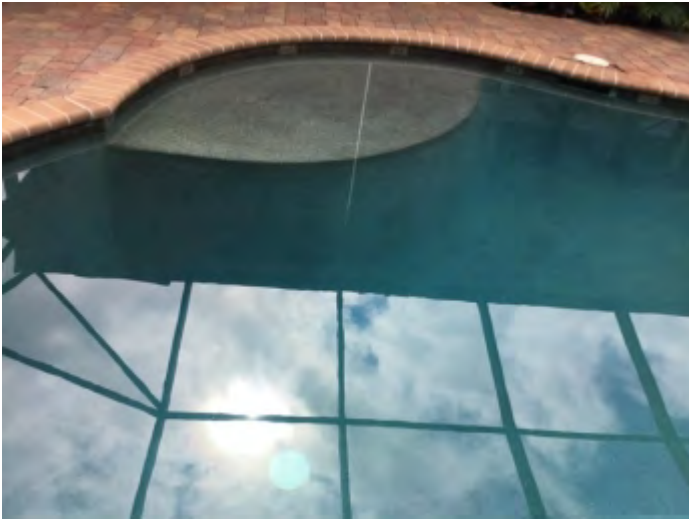
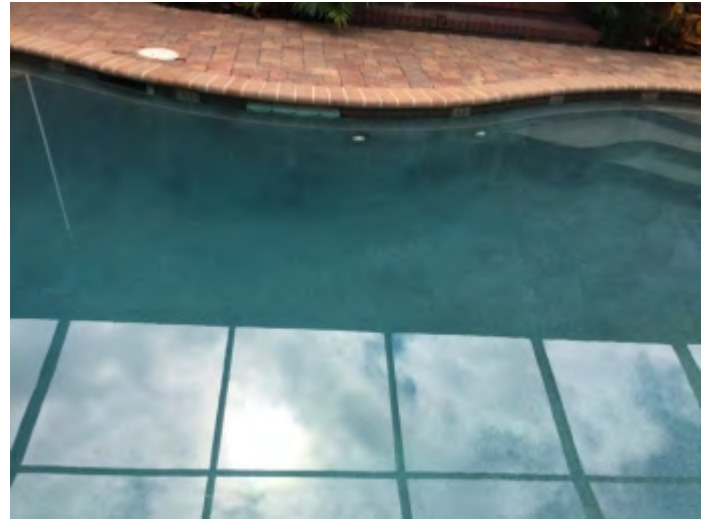
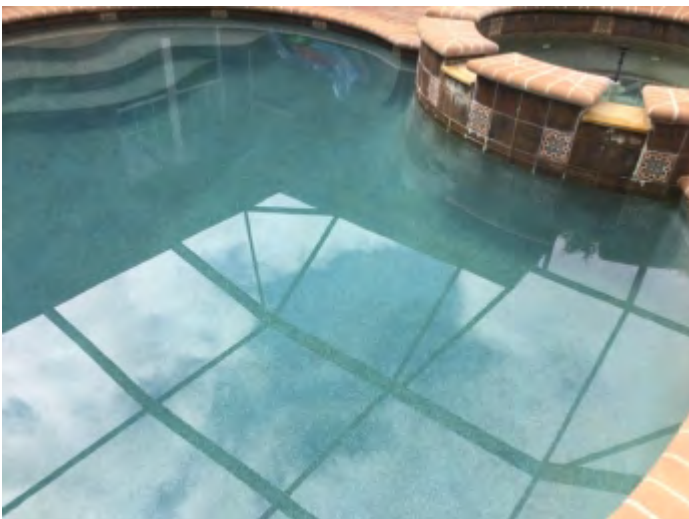
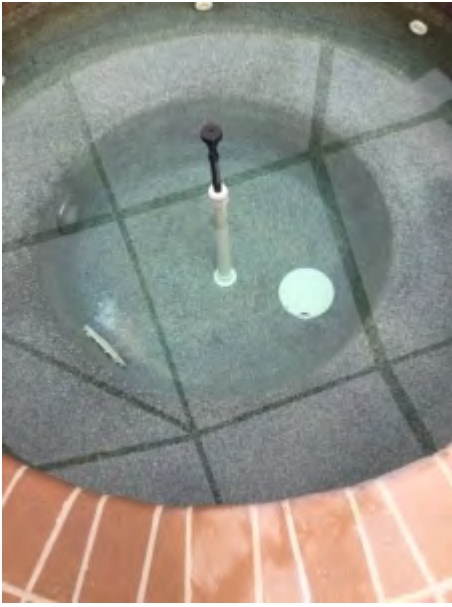
## Pool Surface:

Type/Style:	Marcite- med. blue with heavy aggregate
Condition:	Pool finish is in good condition for being 13 years old.
Notes:	There is a small amount of calcium deposit in the deep end by the light as well as minor scaling throughout which can be expected with age and a salt pool.
Suggested Repairs	Balance chemistry and treat periodically with a scale treatment.

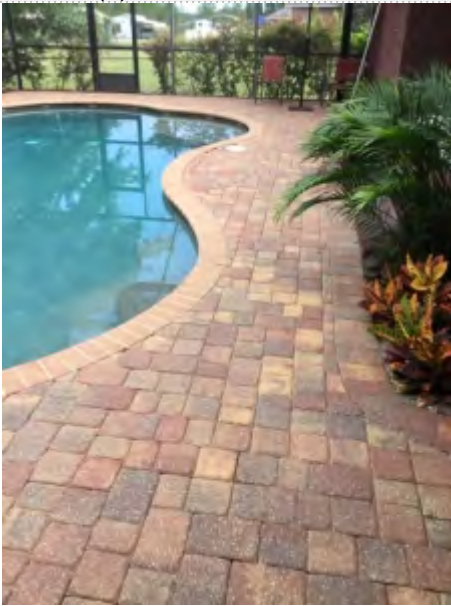
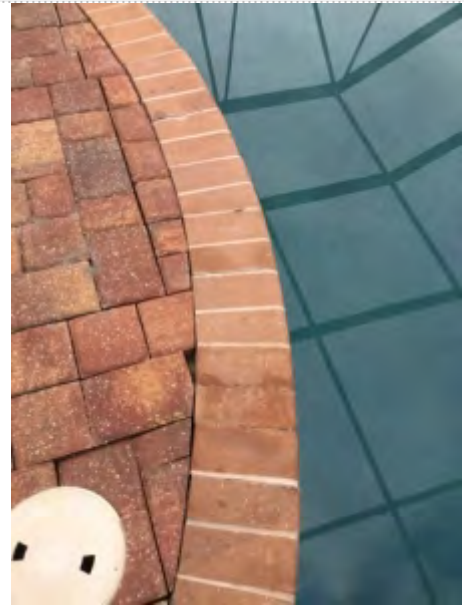
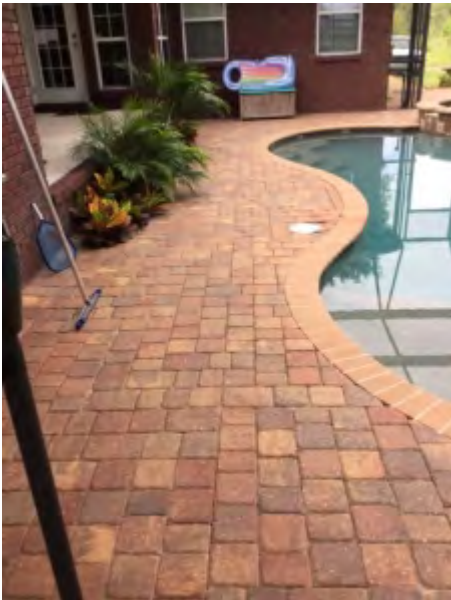
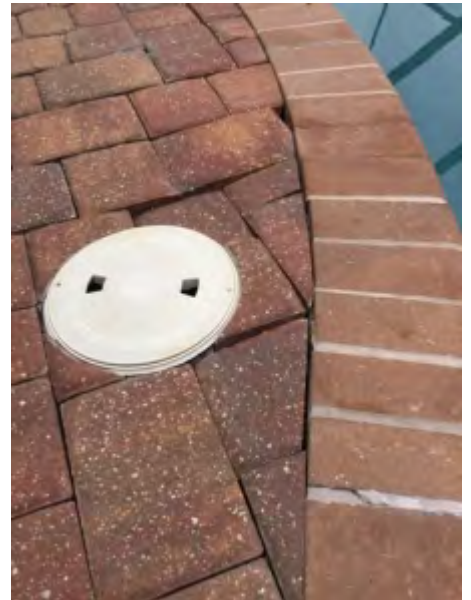
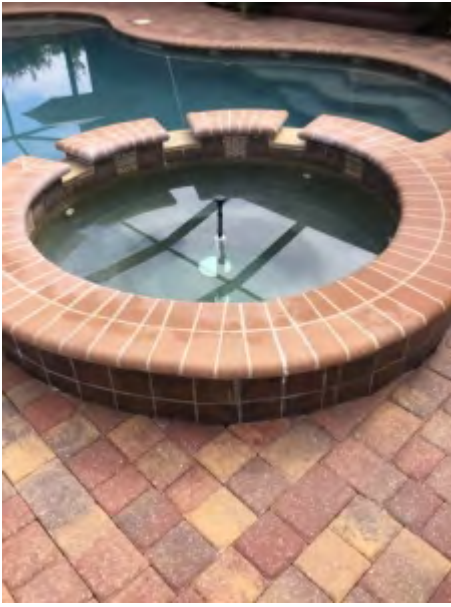
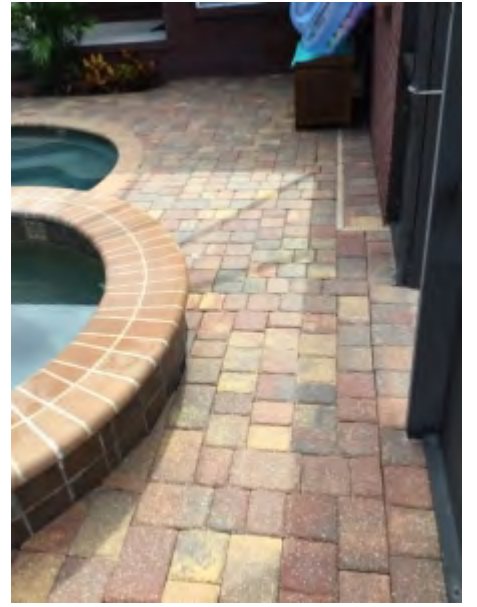
# Deck

Type/Style:	Paver Deck And coping
Condition:	Pool deck is in fair condition
Notes:	There is about a 8' section of coping out in front of the skimmer that is loose ( SAFETY HAZARD ) and will need securing and another corner piece of coping at the far end of the sundeck that is loose as well. There is some sinking around the skimmer as can be expected.
Suggested Repairs	Secure loose coping and relevel pavers around skimmer - *Requires separate quote

The pool finish is in good condition and could use some chemistry help with the scaling and leeching. There are some issues with the deck around the skimmer and coping on the Pools edge that will need leveling and securing. The pavers were recently sealed. There are a few tiles that will need reattached and grouted on the pool edge.

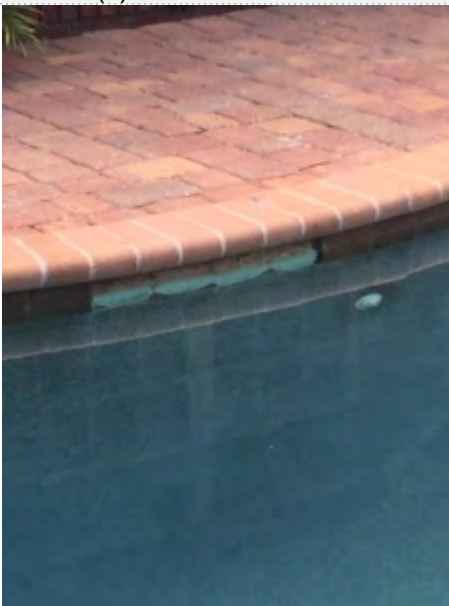
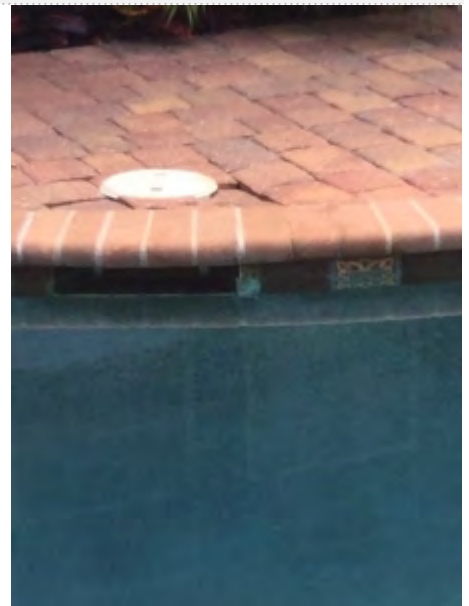
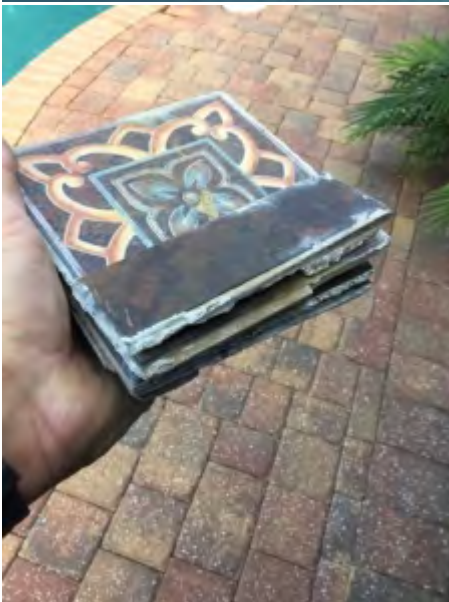
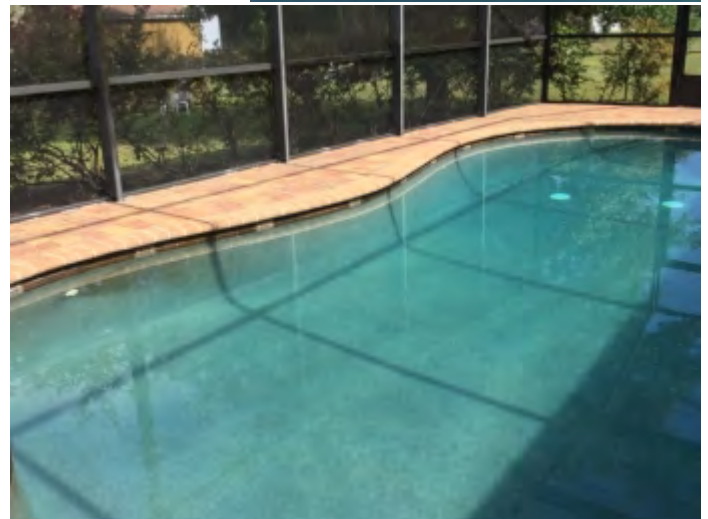
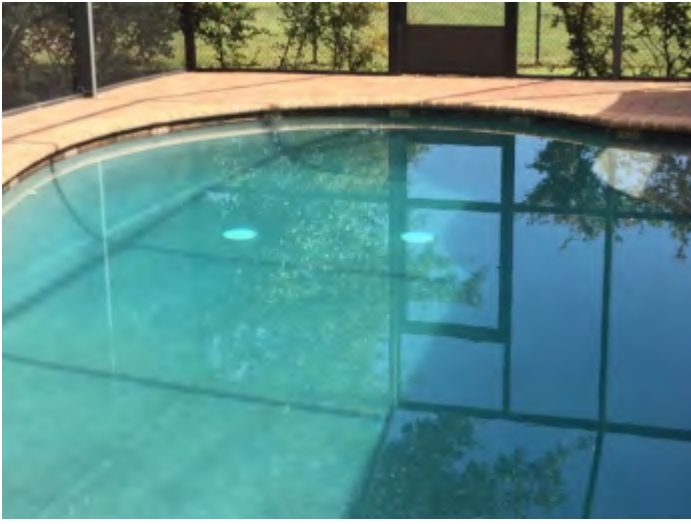
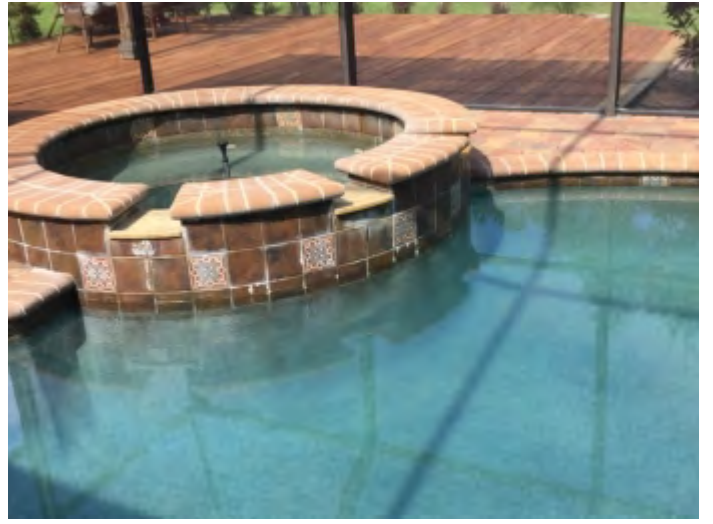
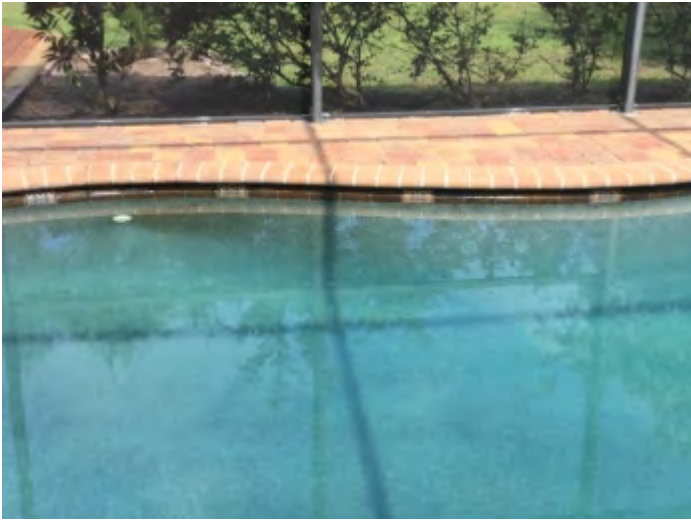
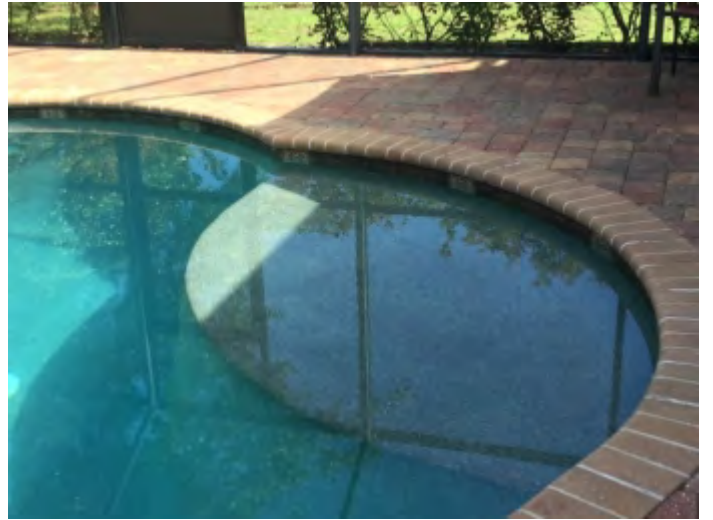
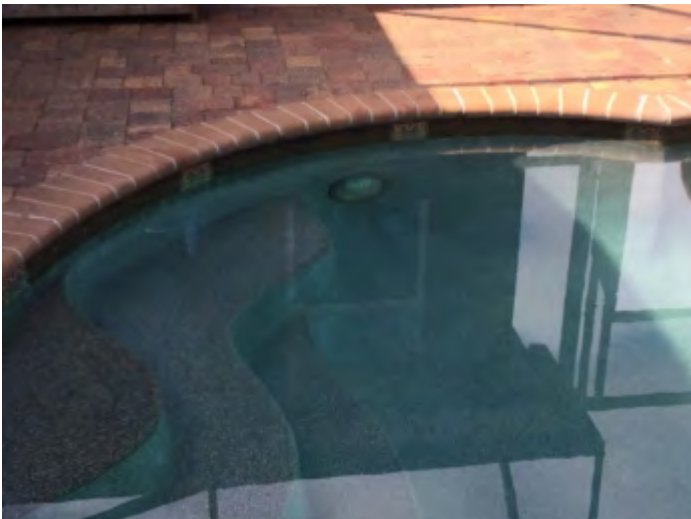
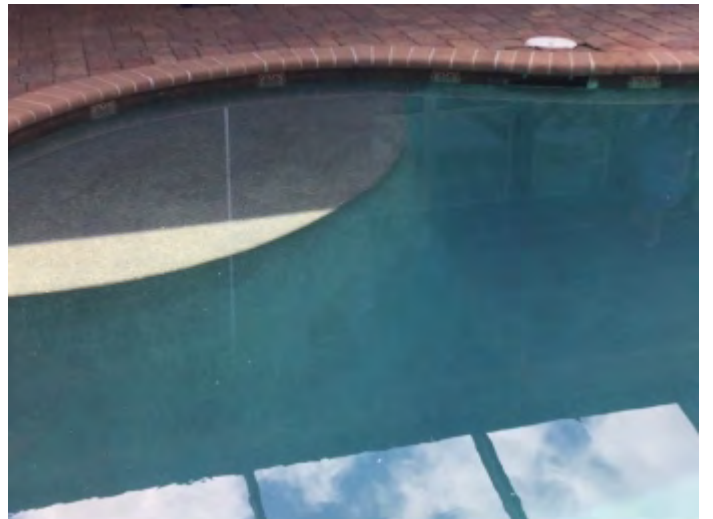
# Tile

Type/Style:	Single row tile with decorative inlays. Multiple rows of tile at the spa wall with inlays and in spa
Condition:	Tile is in fair condition
Notes:	There are about 5 - 6 pcs of tile missing near the skimmer mouth , and one right at it. The missing tiles are still at the pool area. There is some scaling on the spa wall tiles as well.
Suggested Repairs	Replace grout and missing tiles. Clean scale off of spa wall. - *Requires separate quote

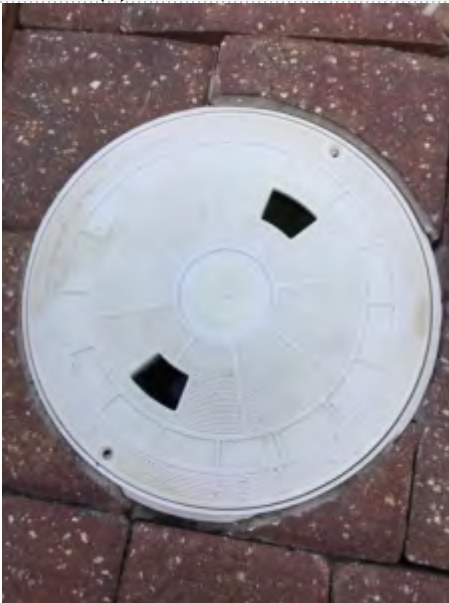
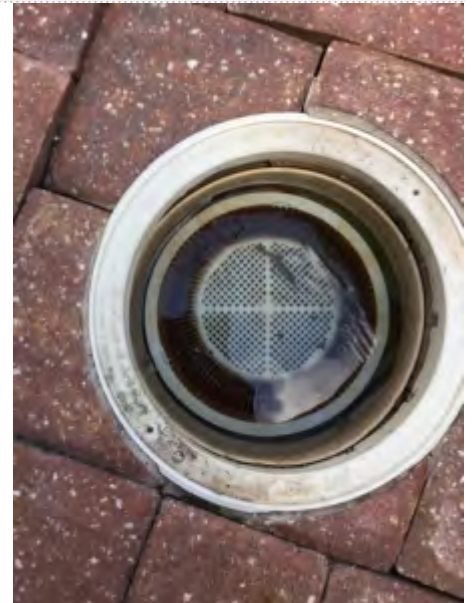
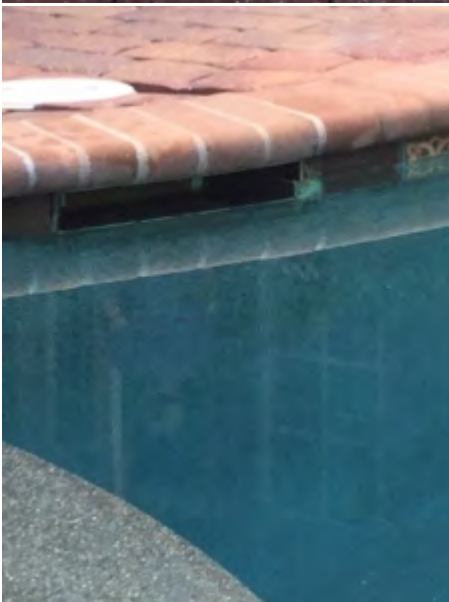
# Skimmer

Pool:	Pool
Type/Style:	STD in deck
Condition:	Skimmer is in fair condition
Notes:	There were no cracks in the body of the skimmer, There were however some missing tiles on the left side of the skimmer mouth and a loose one on the right side of the skimmer mouth as noted previously.
Suggested Repairs	*See Tile

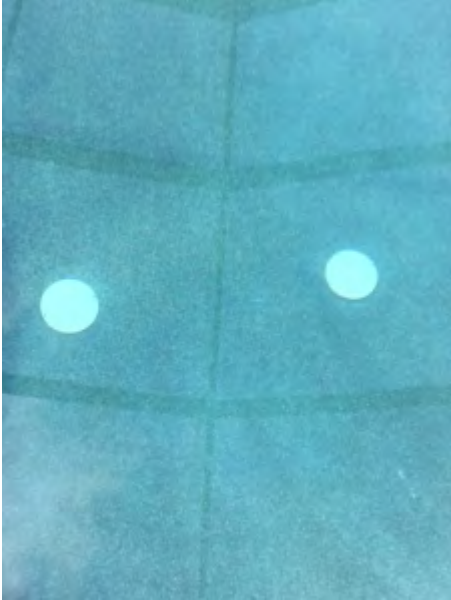
## VGBA Main Drain

All three main drain covers will need replaced with compliant covers.

Replace main drain covers with VGBA compliant covers - \$350

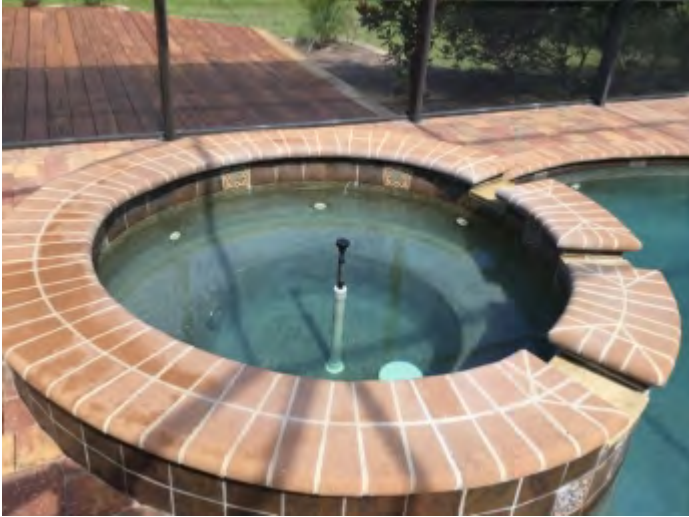
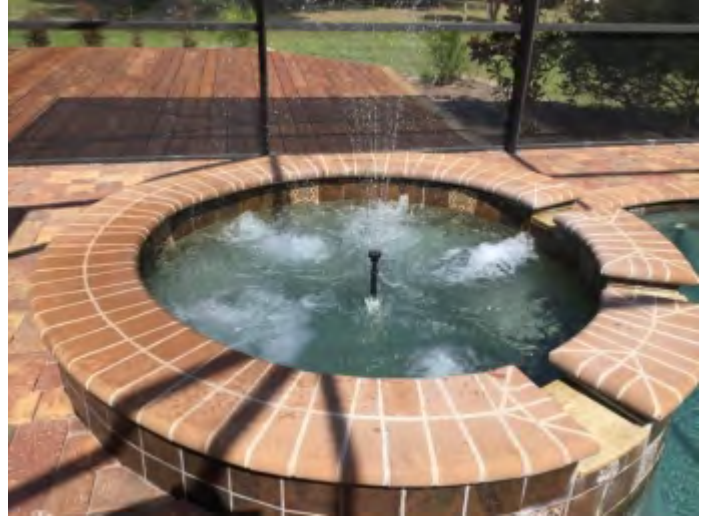
## Spa/HotTub

Std built in Spa

Spa is in good condition

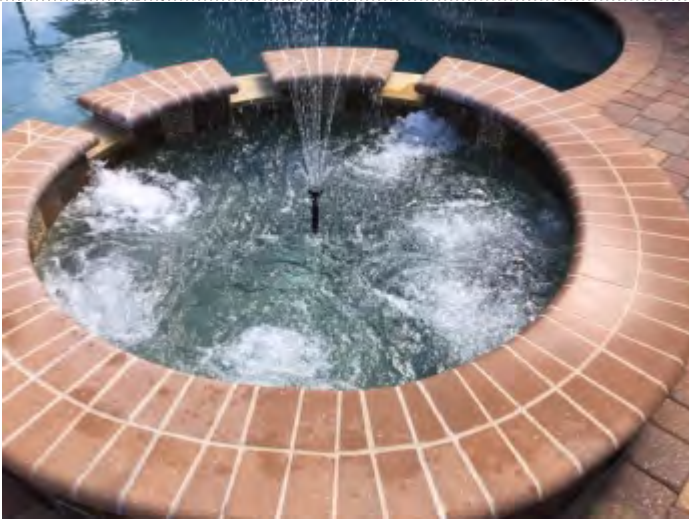
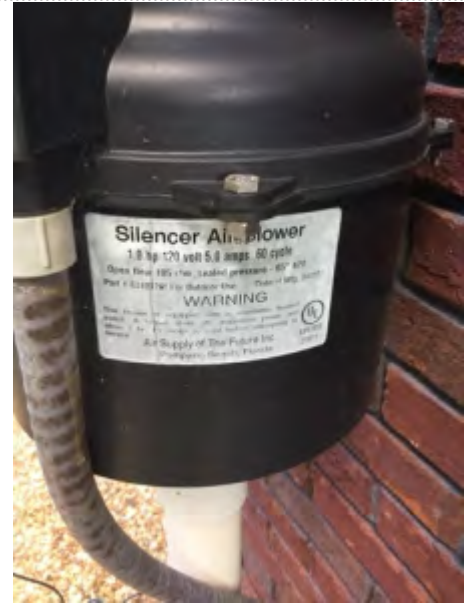
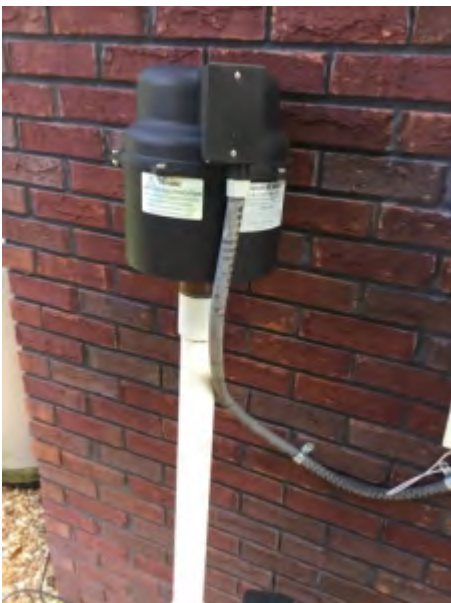
## Spa Blower

Type/Style:	Air
Make/Model	Silencer 1 hp
Functional:	Yes
Suggested Repairs	None
